**Jet-Grouting case history:  
OLYMPIC VILLAGE-  
FALSE CREEK  
VANCOUVER, BC,  
CANADA**

**Abstract**

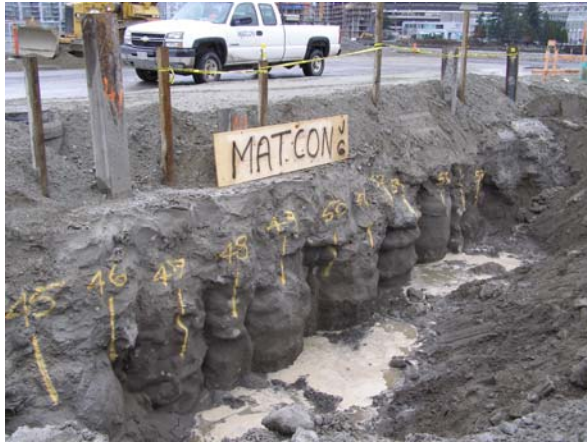
Photo2

Photos 2-3 and 4 show the results of the test carried out on the West wall.

Photo 2 shows the complete excavation of the area of the test and photos 3 and 4 two details of some of the columns.

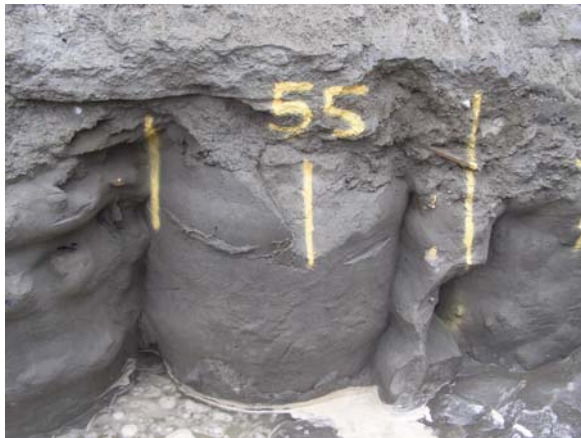
Photo 3

As can be seen on photo 3, columns 53, 55 and 57, constructed prior to columns 54 and 56 (Space Split Method was used), show a diameter of around 1.2 m. The adjacent columns were relatively narrow due to lack of space. The overall effect of the wall was still very acceptable but the result was not considered optimal in terms of homogeneity of the wall and overall consumption

of cement. The parameters of Jet-Grouting were modified consequently to obtain a better column diameter consistency.

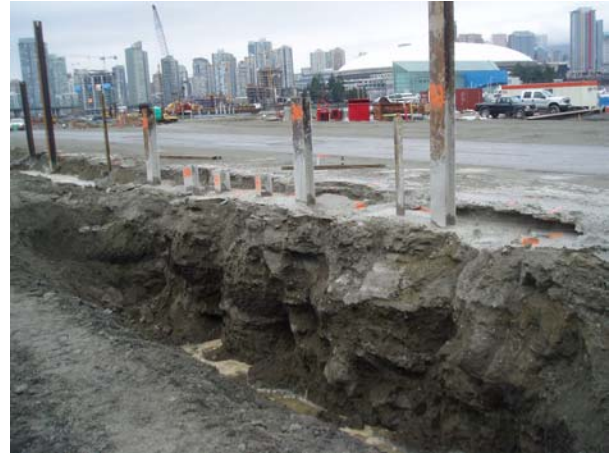
Photo 5 shows the test done at the North wall. The wall appears quite homogeneous and thus the parameters chosen were adopted for the area.

Photo 5- North Wall

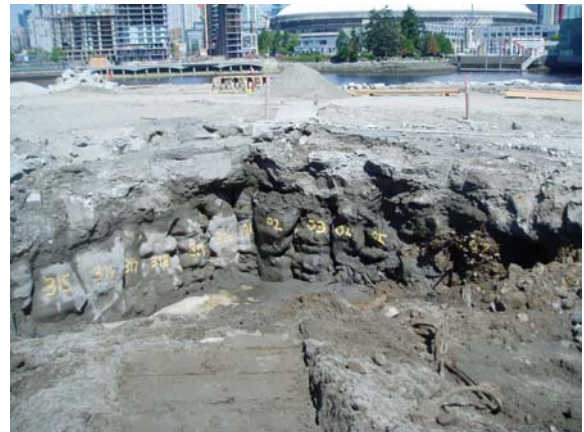
Parcel 4 was the most critical area being the closest to the ocean. The result of the test was positive as evident in photo 6.

Photo 6- Parcel 4 North West corner

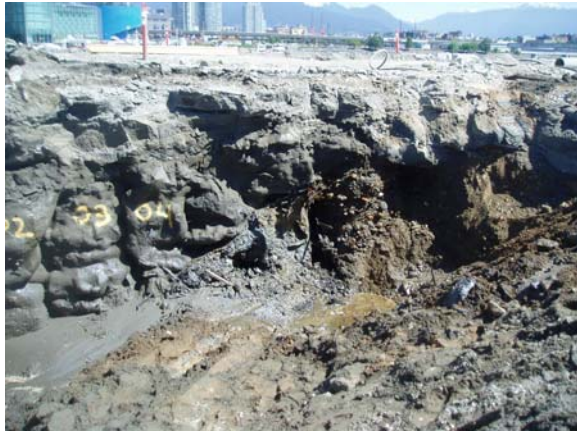
Photo 7– Parcel 4 detail of Photo 6

From Photo 7 we can clearly observe the inclined excavation plan that indicates the boundary between the historic fill soils and the recent fills (sand placed by the City). Note the extreme flexibility of the Jet-Grouting and in particular the ability to create uniform diameter columns in different soil types. The presence of wood and steel from the historic fills can be seen in the photo. There was no use of imported sand at the north and east walls of parcel 4, which was not anticipated.

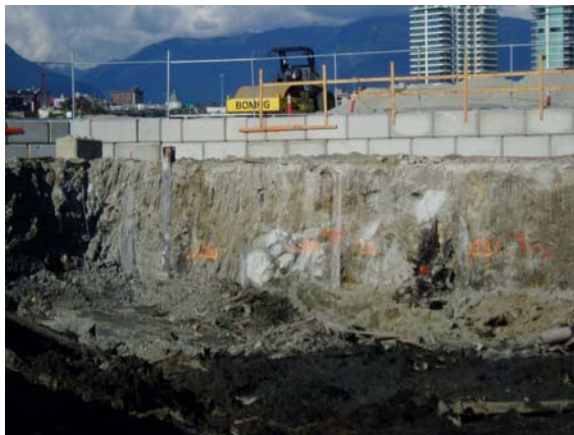
Photo 8 shows the presence of boulders, previously detected during exploratory drilling, easily drilled and jet-grouted, on the East wall of parcel 4.

Photo 8 – Parcel 4 East Wall- Boulders

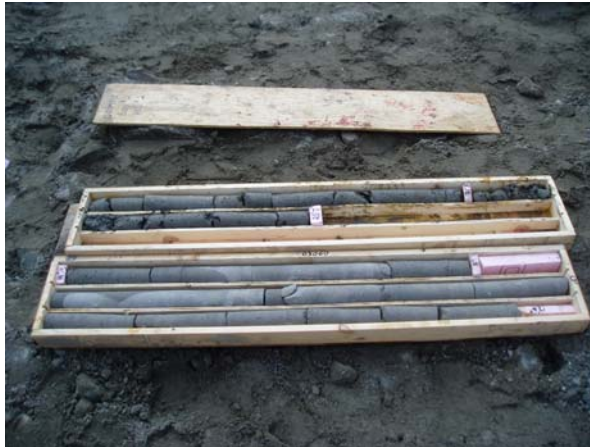
Five cored holes, with triple core barrel, were carried out for the purpose of obtaining samples and evaluating the characteristics of the soil/cement wall.

Photos 9 and 10 show an example of the cored columns and samples.

Photo 9- Coring of Jet-Grouted columns

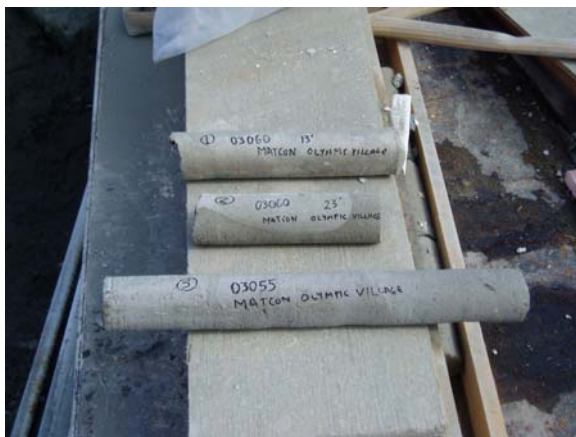
Photo 10- Samples

Average UCS was 8.5 MPa in 11 tests and permeability

was  $5.2 \cdot 10^{-8}$  m/s (average) in the 4 lab tests done.

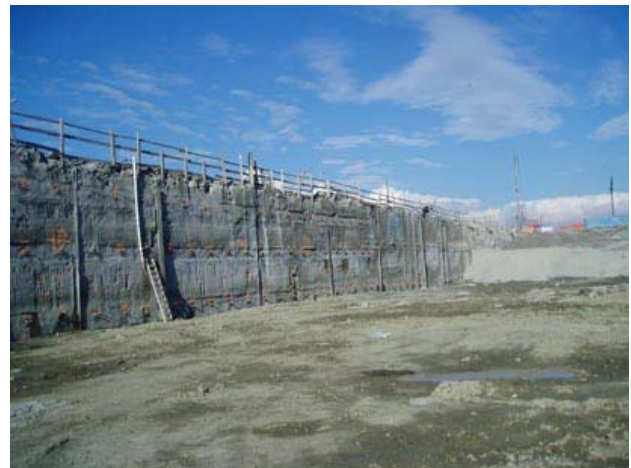
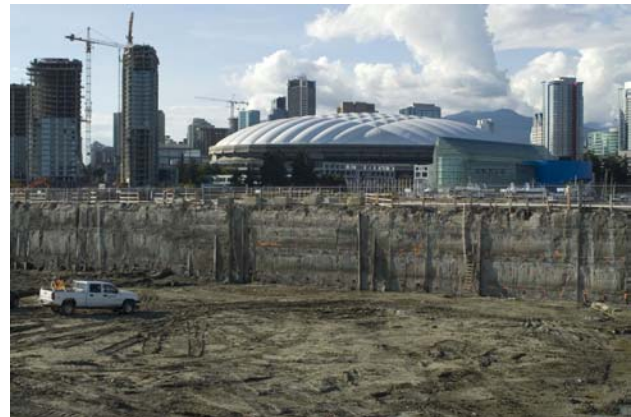
The entire wall was exposed during excavation and it was easy to directly observe the results. No major defects were detected and the excavation was completed without any problem of water seepage or instability. See photo 11 and 12 with the details of the wall excavated.

Photo 11- Excavated and trimmed jet-grouted wall

Photo 12- Excavated and trimmed jet-grouted wall
